SLA Document COS-001	SilverLight Aviation 40420 Free Fall Ave, Unit A Zephyrhills, FL 33542. USA info@silverlightaviation.com	SAFETY ALERT / SAFETY DIRECTIVE	
		Release Date: 01/15/2018 Effective Date: 01/15/2018	Notice # 003 Superseded Notice # __ <i>(if applicable)</i> Page 1 of 8
Limitations for completion of any required corrective actions: Inspection before next flight. Install with Red Loctite Threadlocker 271 within next 5 hours		Affected Aircraft Make and Model: AR-1 Aircraft Serial Number(s): 0001 through 0017

Reinstalling Nose Gear Spindle Bolt Using Loctite 271 (Red)

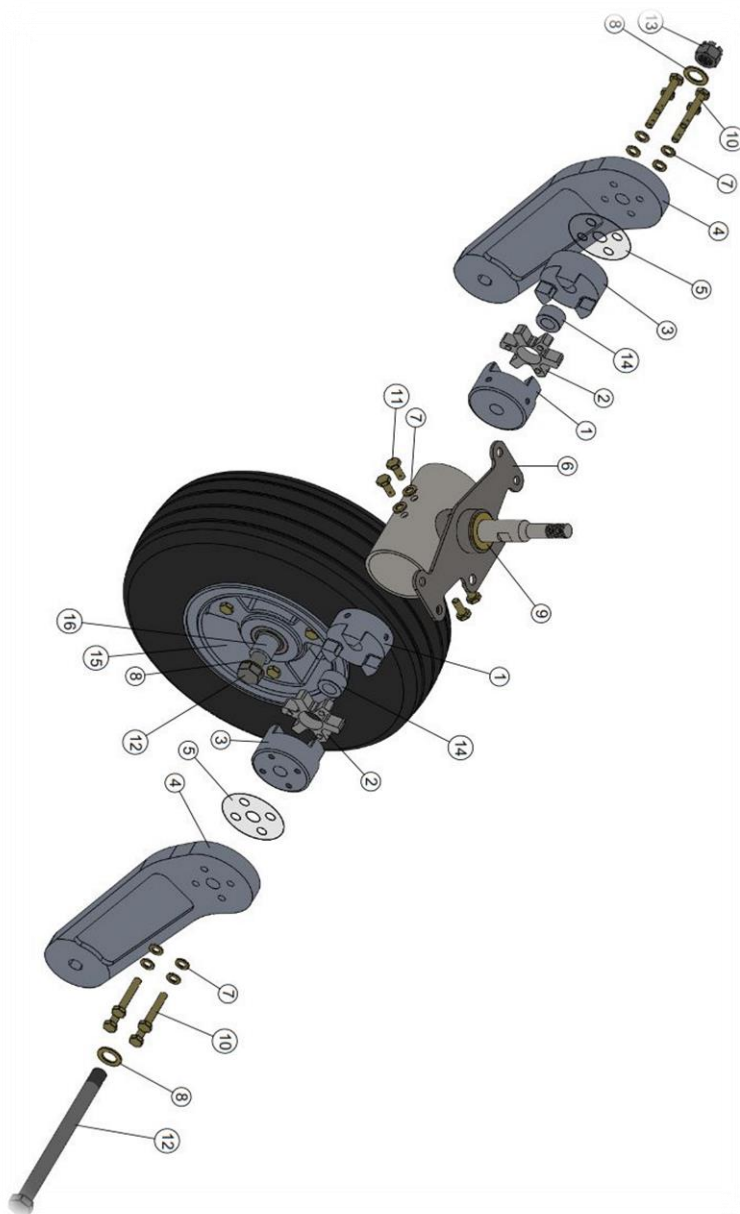
7. The whole front fork assembly is shown below in Fig-1 including the spindle bolt. Fig-2 shows the sub-assembly which is the concern of this bulletin. Fig-2 shows nose gear spindle bolt as item number 4 (Part# 715640). It would good to study these figures before attempting this task.

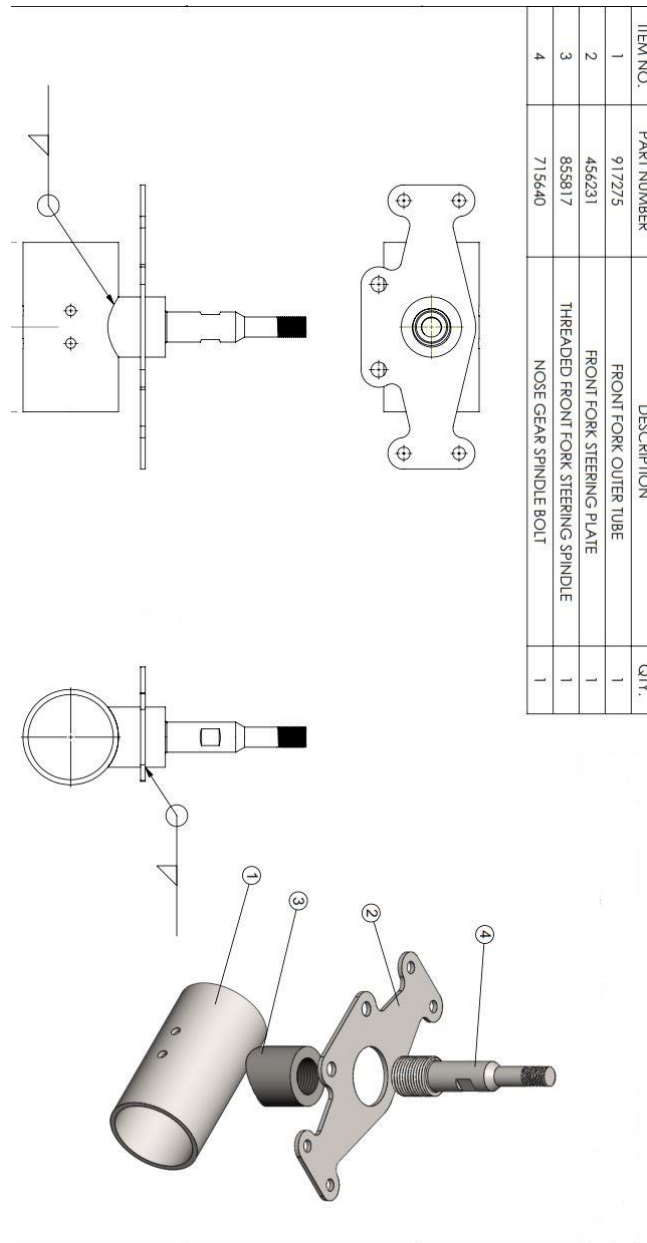
Fig-2

The front fork assembly of AR-1 gyroplane has a spindle bolt that screws into the lower fork assembly and is tightened with Blue Loctite to 50 foot pounds. In one aircraft that bolt broke the torque and over time unthreaded. The pilot/owner discovered it right after a back wheel landing. Once the front wheel touched down, he had hard time turning. Upon inspection he found the spindle bolt had unthreaded from lower front fork assembly.

8. Using a 5/8" wrench on the spindle bolt flat spots and holding the front fork in place, unscrew the bolt from the front fork lower assembly
9. Use Loctite Threadlocker 271 (Red) or equivalent on the threads of the bolt (3 to 5 drops). Then reinsert the spindle bolt into the lower front fork assembly and using the 5/8" wrench tighten up the bolt into the front fork assembly. Tighten it as much as you can. Apply liberal amounts of grease on the spindle bolt shank
