<b>SLA</b> <b>Document</b> <b>COS-001</b>	<b>SilverLight Aviation</b> 40420 Free Fall Ave, Unit A Zephyrhills, FL 33542. USA info@silverlightaviation.com	<b>SAFETY ALERT / SAFETY DIRECTIVE</b>	
		<b>Release Date:</b> <b>03 / 26 / 2019</b> <b>Effective Date:</b> <b>03 / 26 / 2019</b>	<b>Notice # 005</b> Superseded Notice # __ <i>(if applicable)</i>  Page 1 of 11
<b>Limitations for completion of any required corrective actions:</b>  <b>Before next flight</b>		<b>Affected Aircraft</b> AR-1  Aircraft Serial Number(s): All

## Removal and Replacement of Cable/Zip Ties connected to Oil Cooler Aluminum Fittings

Field report of damage caused by cable/zip ties on Oil radiator/cooler Aluminum fittings that connect to the body fairing

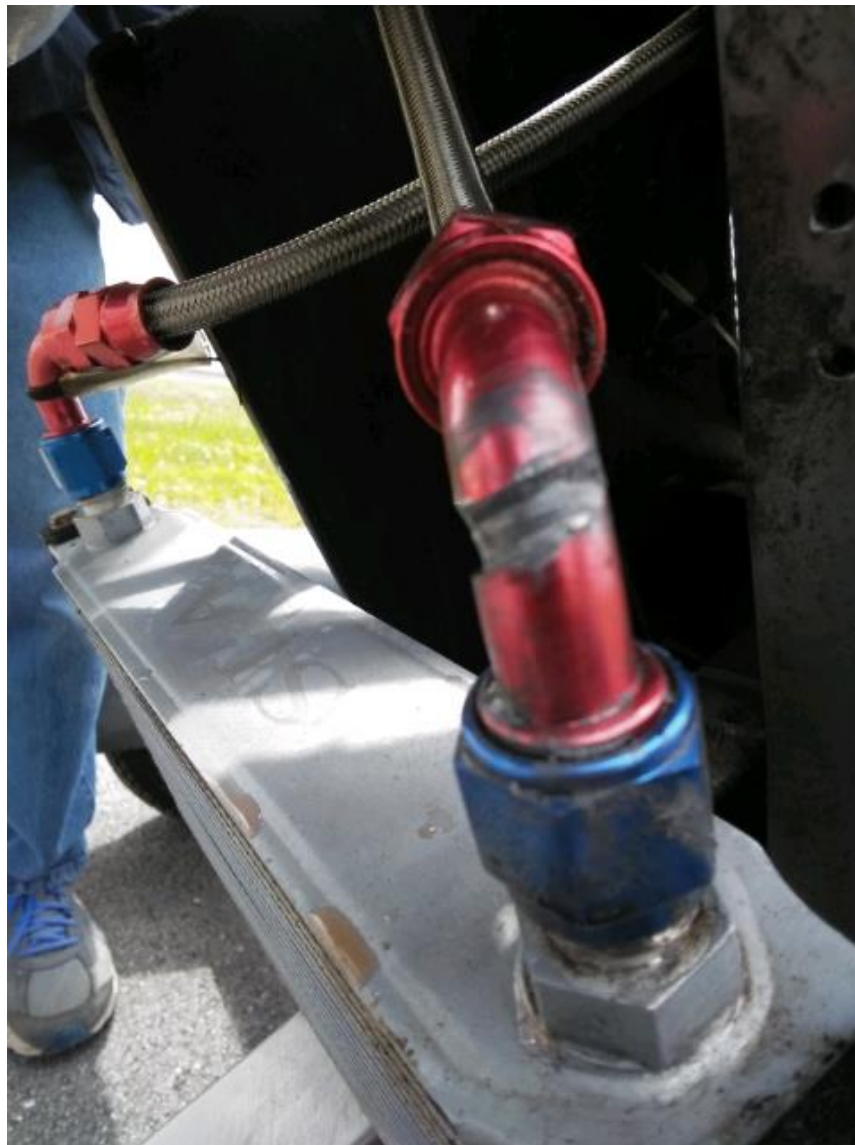
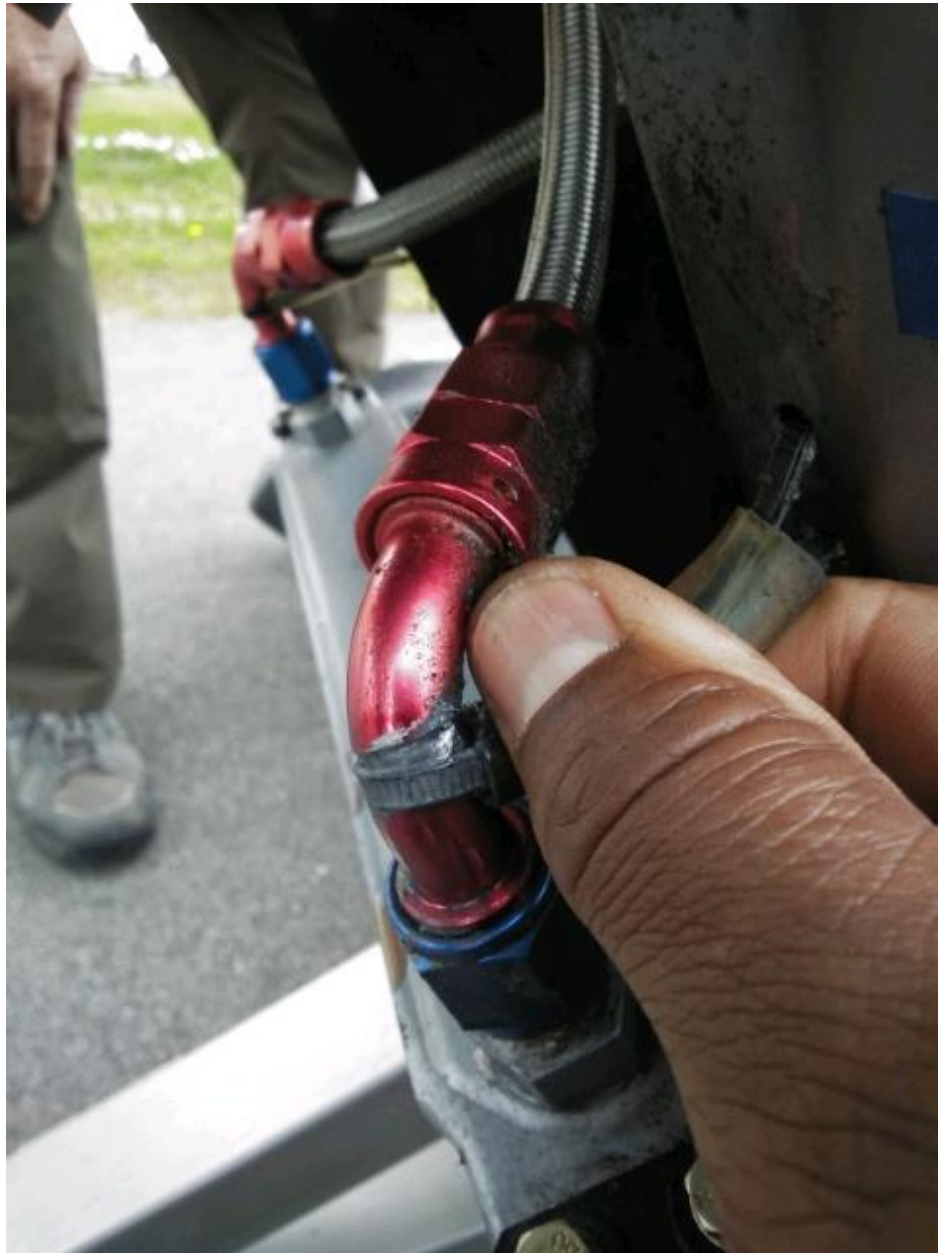
Due to a deviation in assembly procedure, recently field reports have come to SilverLight Aviation's attention that show that plastic cable ties or as they are sometimes called zip ties that connect oil cooler lines to the main body fairing over a period of time and use and with vibration and being left loose have moved causing damage to the oil fittings. In one case the damage was severe enough that in more use, the fitting would have leaked oil possibly causing engine

damage and thus a serious condition. The pictures of this damage are shown below:

To rectify this condition, follow these guidelines:

- 1) Cut these and remove the cable ties.
- 2) Loosen the bolt that holds the oil cooler bracket secured to the keel tube and slant or angle the cooler so it's close to perpendicular to the keel tube diagonal member its affixed to. Make sure there is enough of an oil line to have slack that this angle does not cause oil line routing to touch or rub against anything. Adjust the angle if necessary
- 3) Tighten the bolt. This will bring the fittings farther away from the body fairing.
- 4) Now you can use replacement cable ties to affix the body fairing to the oil lines themselves and not to the fitting. The cable ties through the rubber hose standoff should be very snug so that there is no movement possible. If needed, use a new rubber hose (fuel line) standoff and cut it to size. Use flush snips.

If there is extensive damage like shown in above pictures to the oil fittings, contact the factory to purchase replacement oil lines. They will have to be replaced and oil circuit purging procedure as specified by Rotax when oil circuit is opened and gets air in it will need to be followed.

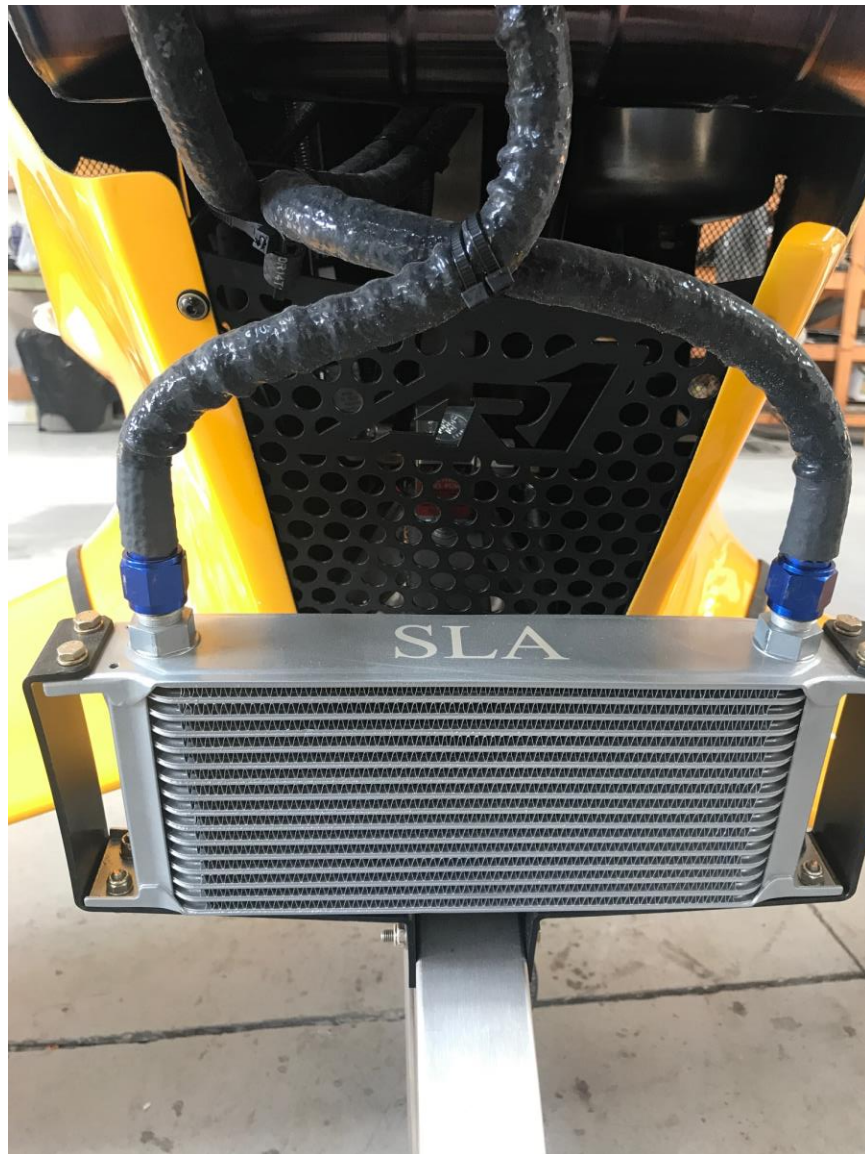
Newer production is using different method of oil hoses and body fairing tying and can be seen below in images.

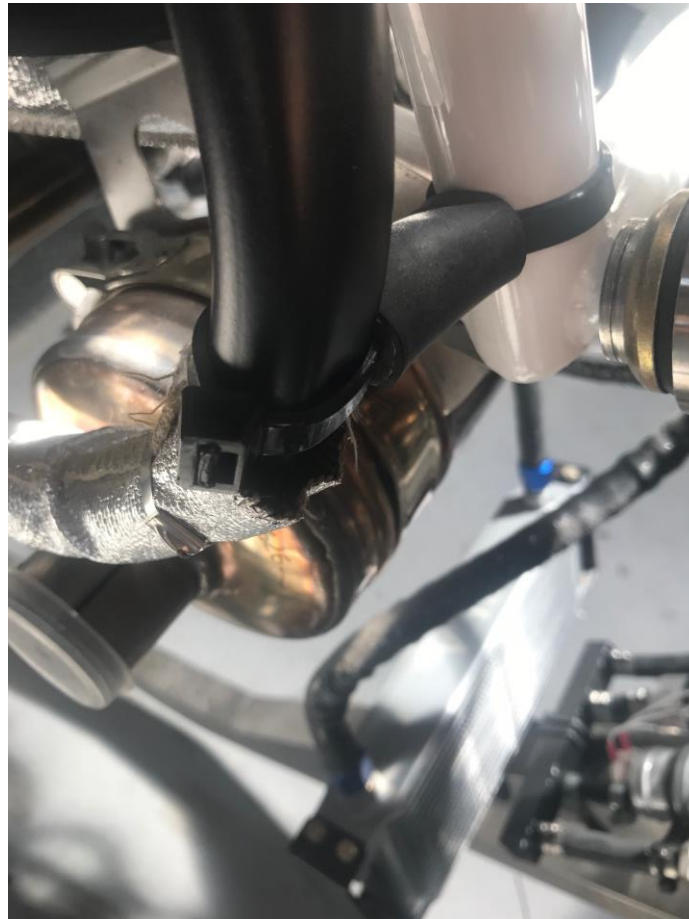
Please note that cable tie with standoff may also be used against Aluminum tubing for coolant to separate it from touching the ring mount in your aircraft. If so, please inspect this area as well and if the cable tie was kept loose, this area could also experience damage.

We advise that cable ties be checked and replaced on annual inspection depending on condition and when replaced, the installation should make sure that they are fairly snug so no movement is allowed on them. Keeping them loose is not a good practice as they can easily move and with aircraft vibration start to rub into metals
