SLA Document COS-001	SilverLight Aviation 39514 Aviation Ave Zephyrhills, FL 33542. USA info@silverlightaviation.com	SAFETY ALERT / SAFETY DIRECTIVE	
		Release Date: 11/17/2022 Effective Date: 11/18/2022	Notice # 006 Superseded Notice # __ <i>(if applicable)</i> Page 1 of 18
Limitations for completion of any required corrective actions: Inspection before next flight. Replacement within next 10 hours		Affected Aircraft Make and Model: AR-1 Aircraft Serial Number(s): All with new tail using rod end bearing for top hinge

Installing secondary support brace on rod end bearing receptacle for rudder

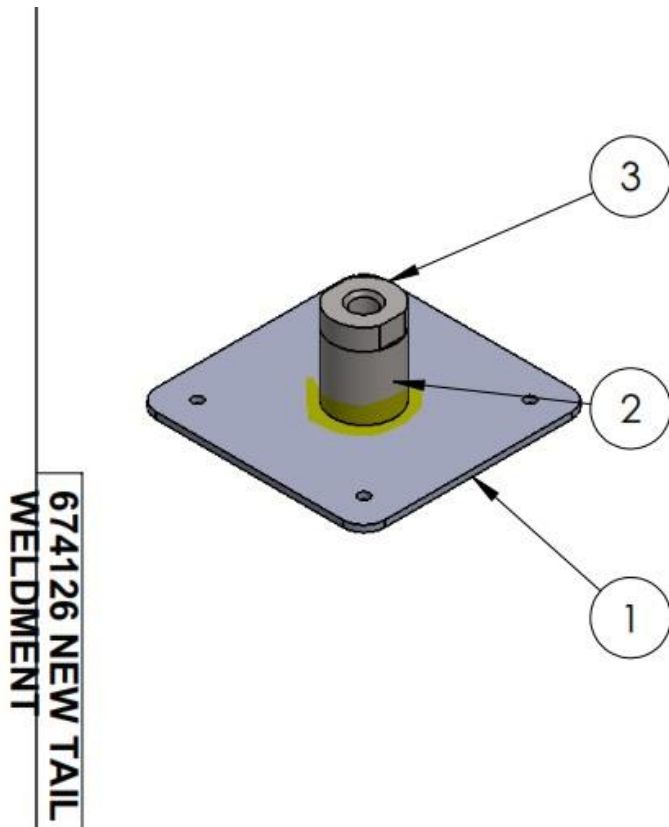
From a field report that showed crack next to the weld on this bracket after trailering and usage. Even though other AR-1 gyroplanes that were also trailered have not shown this and it is possible this is a one off event, it is appropriate to install this brace for peace of mind as many people trailer the gyroplane. This brace will provide extra support and will not just rely on the weld (highlighted area) alone

To provide additional triangulated support to this part so reliance on weld during activities like trailering is reduced or eliminated

A new part with triangulated gussets has to be slid over this part and structurally glued on the flat plate as well as the round tube with provided 2 part structural glue that is mixed 1:1
